# Manhole Inspection Summary

Manhole # S25E\_\_029MH

Insp Date: **8/7/07 9:13 AM**

**Location** Address: **300 CARROLLTON AVE**

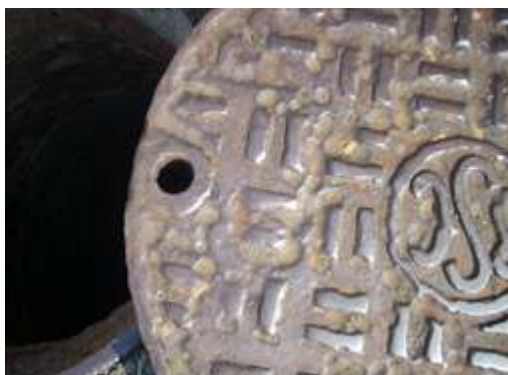
Defect 4

Type: **Sanitary** Condition: **Worn** Cover Material: **Cast Iron**

WORN COVER

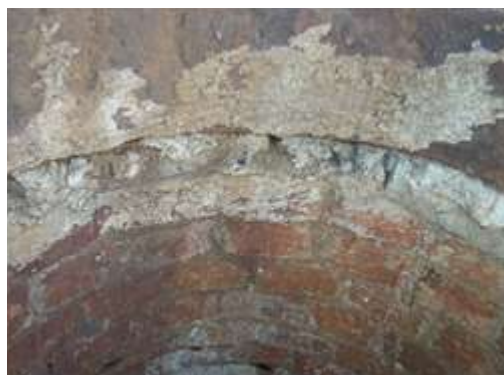
Defect 2

Condition: ☐ Sound ☐ Cracked ☐ Root Intrusion ☐ Loose Brick ☒ **Deteriorated**

DETERIORATED CHIMNEY

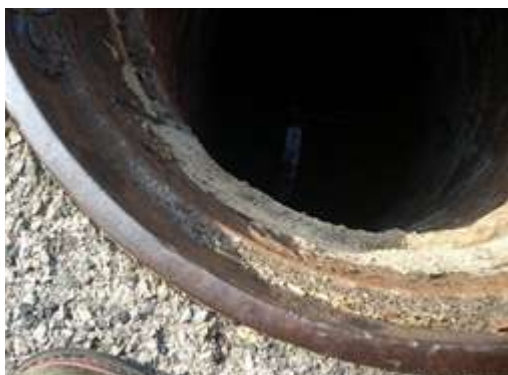
Defect 1

**Frame** Offset: **1** (in.) Condition: ☒ Sound ☐ Cracked ☐ Leaks

FRAME OFFSET

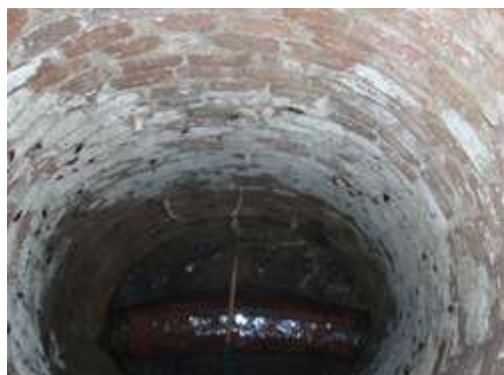
Defect 3

**Steps** Count: **0** Missing: **4** ☐ Corroded

MISSING STEPS

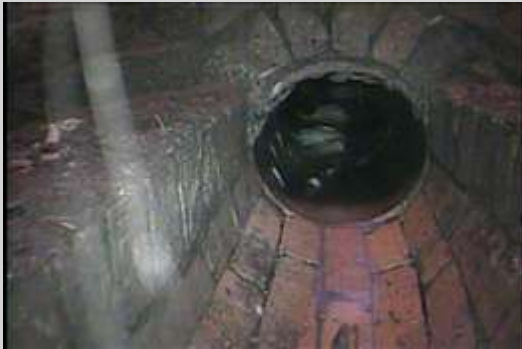
12 O'Clock Outflow

10 in. Circular Gravity Sewer  
Pipe Out @ 12 O'Clock

Pipe Height: **9.6** (in.) Rod and Bar (Angled)  
Pipe Material: **Clay** ☐ Pipe Lined  
Invert Depth: **10.24** (ft.) Flow Characteristics: **None**  
Deposits: ☒ None ☐ Mud ☐ Sludge ☐ Debris ☐ Grease  
Silt Depth: (in.) Deposits Extent:  
Infiltration: **None** Pipe Seal Cond: **Sound**

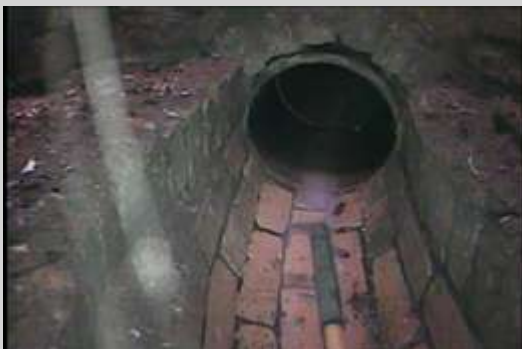
7 O'Clock Inflow

10 in. Circular Gravity Sewer  
Pipe In @ 7 O'Clock

Pipe Height: **9.6** (in.) Rod and Bar (Angled)  
Pipe Material: **Clay** ☐ Pipe Lined  
Invert Depth: **10.09** (ft.) Flow Characteristics: **None**  
Deposits: ☒ None ☐ Mud ☐ Sludge ☐ Debris ☐ Grease  
Silt Depth: (in.) Deposits Extent:  
Infiltration: **None** Pipe Seal Cond: **Sound**
